Santa Ana River PMR Submittal

Submitted by: Riverside County Flood Control
1995 Market Street
Riverside, CA 92501

Study Objective

This study will update the FEMA floodplain for the Santa Ana River within Riverside County upstream of Prado Dam. It will account for the effects of Seven Oaks Dam (built in 1999), improvements to Prado Dam, aggradation/degradation, and a few recently constructed bridges. In addition, the Levee Certification that was submitted for the Riverside Levees along the Santa Ana River used the flow rates from the 1988 USACE hydrology report as opposed to the effective FEMA flow rate. In order for FEMA to allow the use of the lower USACE flow rates for the Levee Certification, this study has to be approved first as a Physical Map Revision.

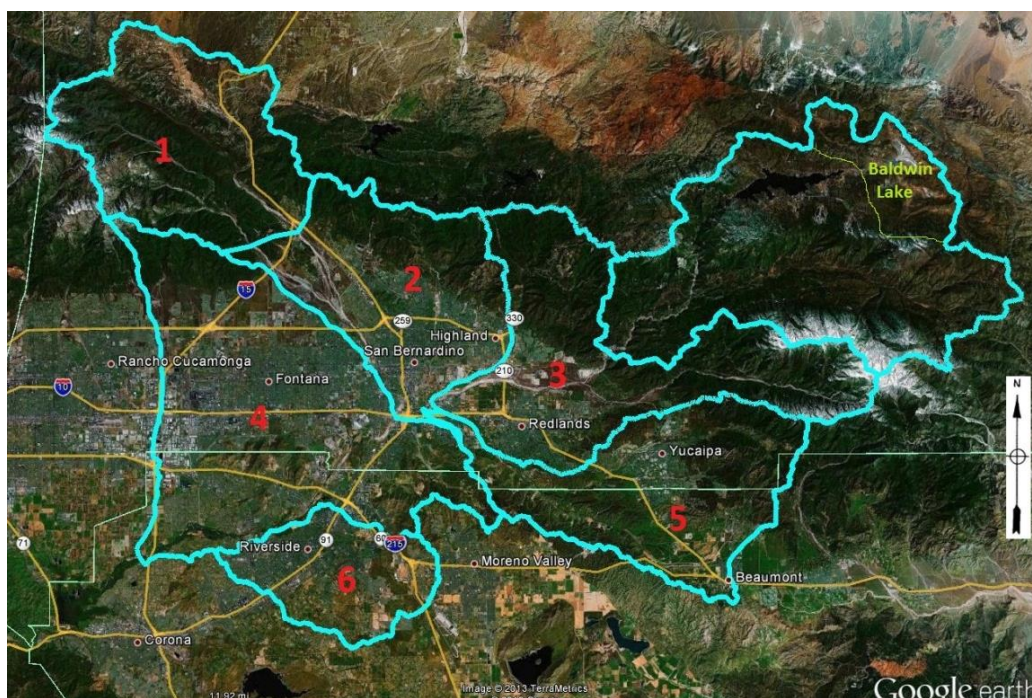
Figure 7: Consolidation of Subwatersheds in USACE 1988 Hydrology Report into Groups

To facilitate this review, the subwatersheds tributary to Prado Dam from the 1988 USACE Hydrology Report were consolidated and weighted impervious percentages were calculated for each group of subwatersheds [Figure 7]. The area tributary to Seven Oaks Dam was excluded from this comparison increased urbanization to the watershed was determined to be negligible. The resulting six subwatershed groups were draped over 2011 aerial imagery obtained from Google Earth [see Appendix C2]. Using the aerial photos, the total urban and natural areas were estimated for each subwatershed group. These areas were then multiplied by a factor to determine the amount of impervious area within the urbanized and natural zones. Weighted impervious percentages were then calculated for each subwatershed group and then for the entire watershed.

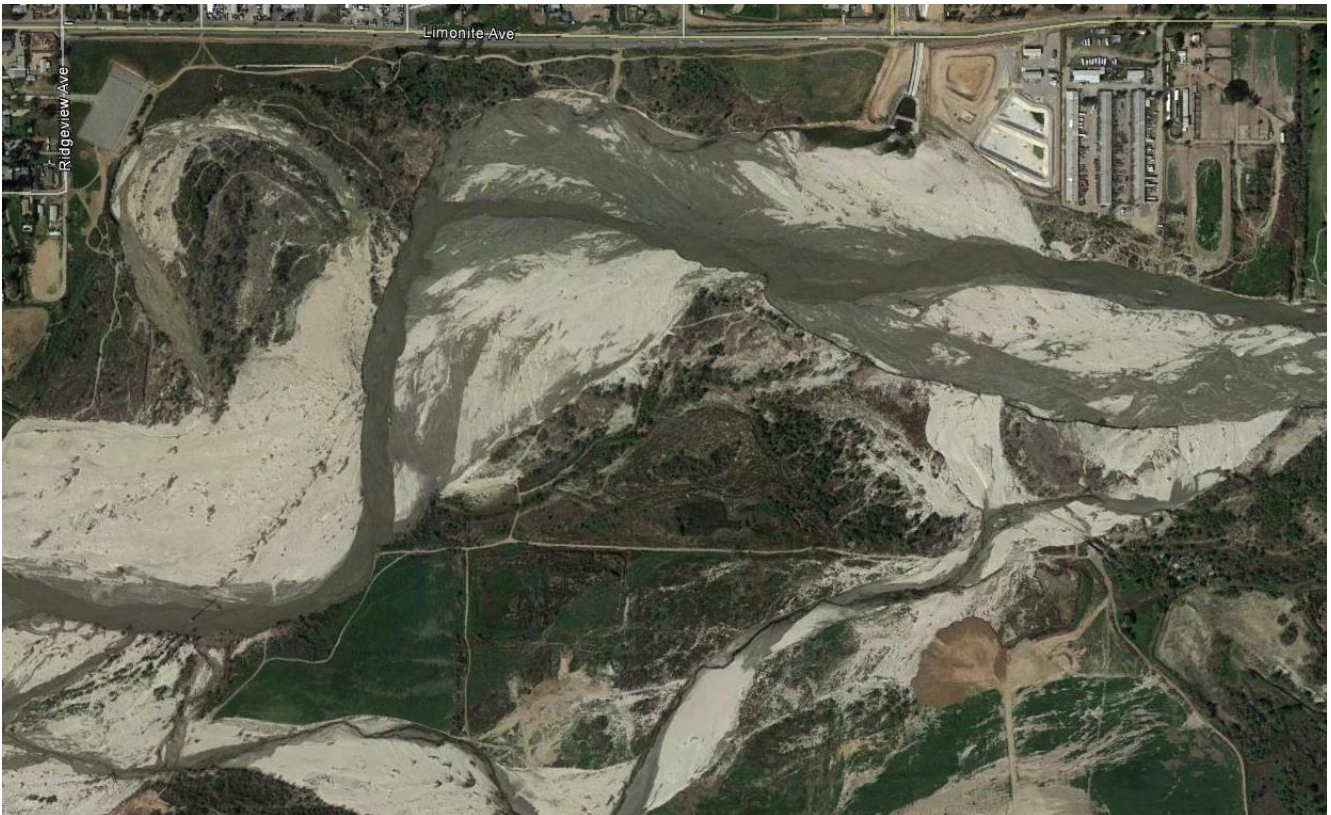
Figure 10: 2011 Aerial Photo near outlet of San Sevaine Channel

Both the 1980 FEMA and 1991 USACE studies for the Santa Ana River floodplain use the existing low flow channel for the stream centerline. It has been noted however, that significant storms can cause migration of the low flow channel as depicted in Figures 9-10. A centerline that follows the low flow channel is not an accurate representation of the flow path or the reach lengths between cross sections during a 100-year storm. Therefore, the centerline for this study represents the main conveyance path that the 100-year discharge would take through the Santa Ana River floodplain. The study baseline stationing is the distance, in feet, upstream of the Prado Dam embankment.

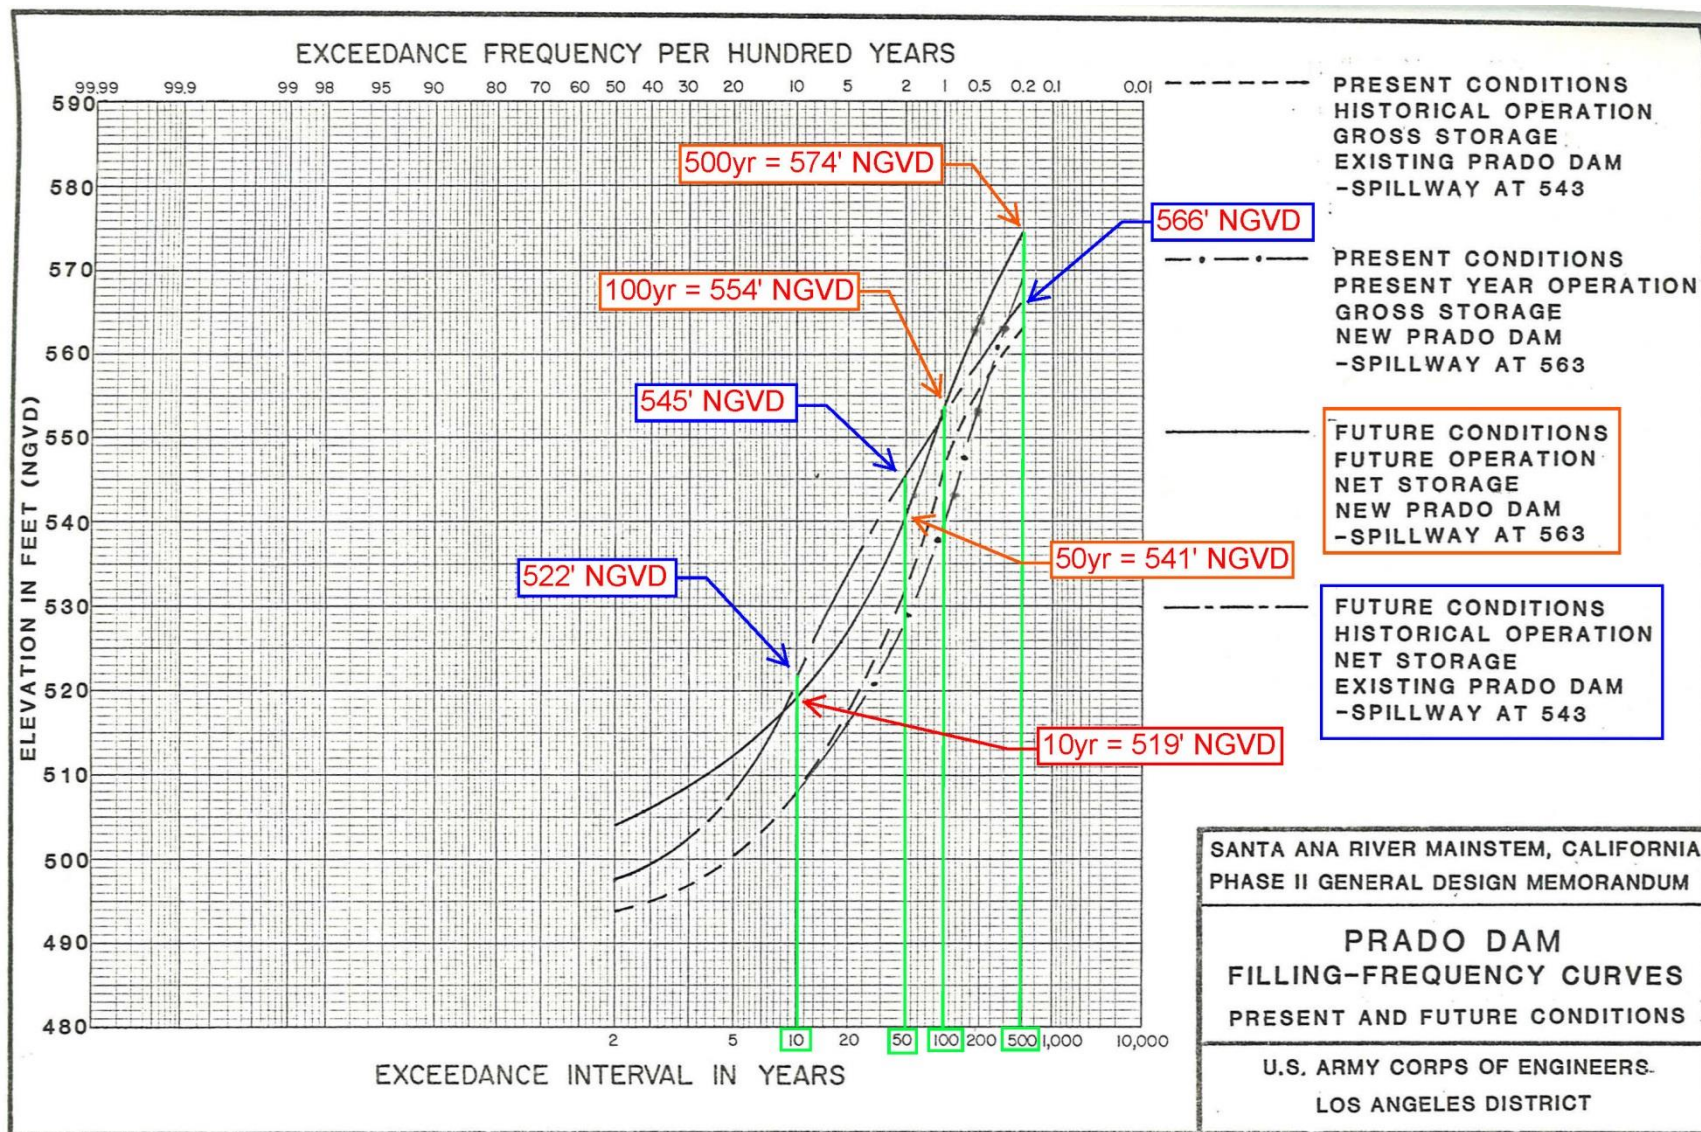
PLATE 7-45
REVISED

Figure 11: Filling-Frequency Curve from USACE 1988 Hydrology Report, see §3.1.6

The downstream boundary condition is based on the Filling-Frequency Curves for Prado Dam contained on Plate 7-45 of the 1988 USACE Hydrology Report. The different filling-frequency curves represent various combinations of present/future watershed conditions and operation of the Prado Dam. Currently, Prado Dam is undergoing improvements to raise the level of flood protection provided by the facility. As of 2012, the dam crest has been elevated and new outlet works have been constructed but the spillway has not yet been raised from 543' NGVD to 563' NGVD. Furthermore, downstream retrofitting efforts have not been completed which limits the amount of flow that can be safely released from the dam. For these reasons, the most appropriate curve for the current 2012 condition is the Future Conditions/Historical Operation/Net Storage/Existing Prado Dam Spillway [indicated in blue on Figure 11]. Table 7 summarizes the downstream water surface elevations that were used for the hydraulic analysis.

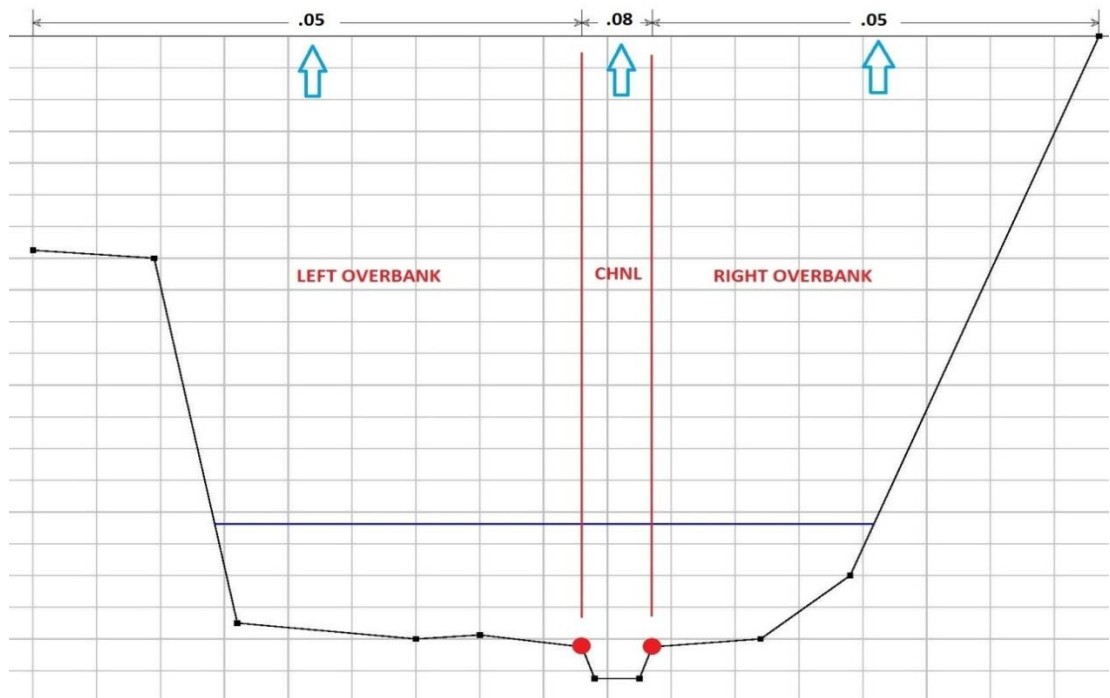
Figure 17: Cross Section 492 from FEMA 1976 Study [blue arrows point at n-value]

An evaluation was made of the roughness coefficients used in the effective FEMA hydraulic model and the 1991 USACE Floodway Delineation study to determine their applicability to this study. Both studies used the banks of the low-flow stream as the boundary between channel and overbank n -values. Figure 17 shows the channel and overbank n -values in cross section 492 of the FEMA hydraulic model. Recent storms of significant magnitude have caused migration of the low-flow channel thus changing the location of the channel and overbank as defined by the FEMA and USACE floodplain studies. Due to this variation in the low-flow channel and to address all the factors affecting roughness, composite roughness coefficients were determined for the floodplain using Cowen's method. The parameters used for the selection of the variables in Cowen's method were obtained from *Open-Channel Hydraulics* written in 1959 by Prof. Ven Te Chow and USGS Water-Supply Paper 2339. In using the Cowen's method, two areas were analyzed separately from the rest of the study reach because of their unique characteristics: the leveed reach and Riverside Narrows

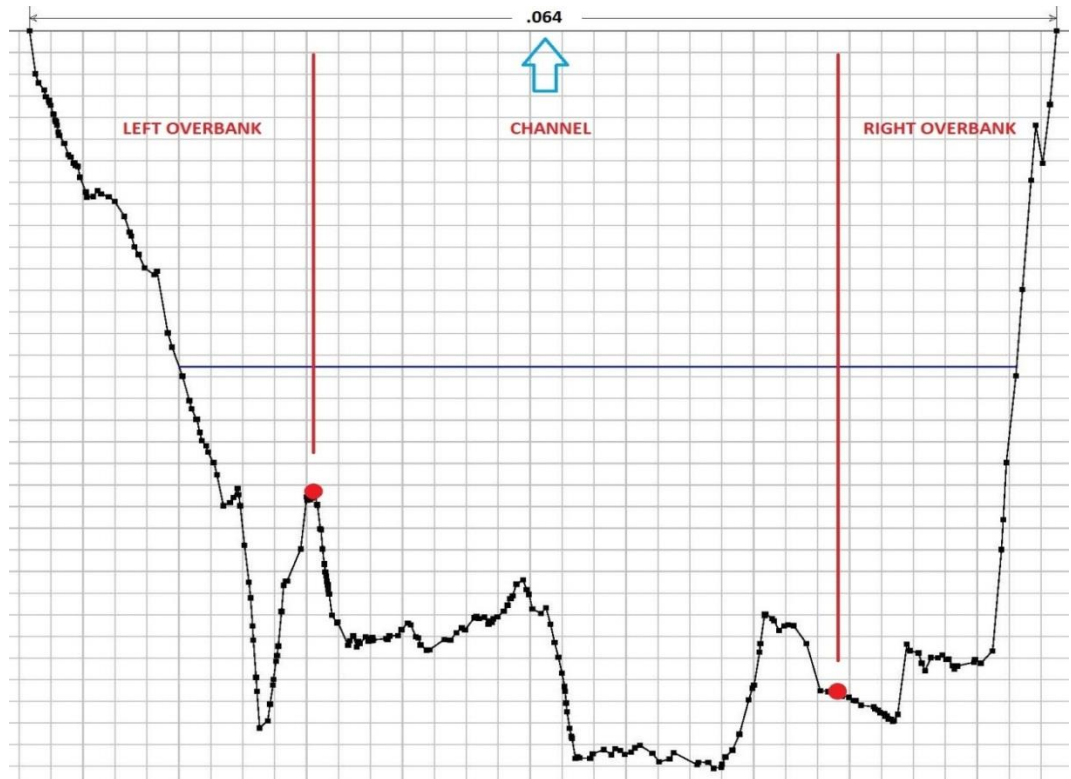
Figure 18: Cross Section 62500 from RCFC Study [blue arrow points at n-value]
